OHIO RIVER BASIN
TWO MILE RUN, VENANGO COUNTY
PENNSYLVANIA

TWO MILE RUN DAM
NDI No. Pa. - 254

6
**PHASE I INSPECTION REPORT
NATIONAL DAM INSPECTION PROGRAM.**

PHASE I INSPECTION REPORT
NATIONAL DAM INSPECTION PROGRAM
TWO MILE RUN DAM
NDI# PA-254, PENNDER# 61-19

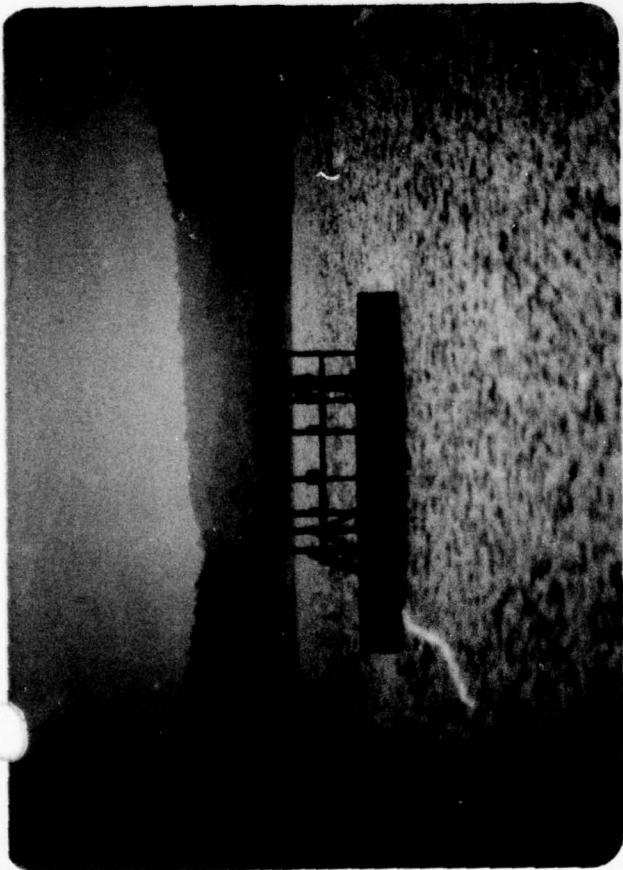
PHOTOGRAPH 5 Telephoto View of the outlet structure at Two Mile Run Dam. See photo 1 for reference.
